STOP EXCESSIVE COOLANT CONSUMPTION OR LEAKAGE!!!!

20574
Engine Manifold
Repair Kit

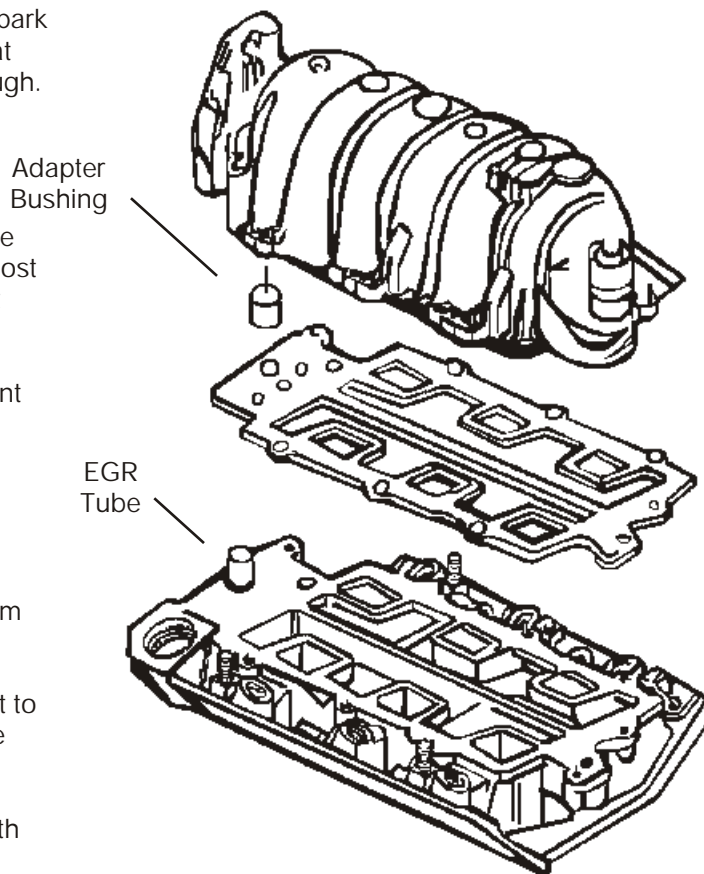
2003 - 1995 GM vehicles with 3.8 L series 2 engines (VIN K - RPO L36) have been experiencing excessive coolant consumption or coolant leakage near or under the throttle body and intake manifold. This is caused when the EGR tube on the lower manifold degrades the composite material of the upper intake plenum around the passage area between the two part manifold. Once the composite material is degraded, it becomes porous and allows the coolant areas on either side of the EGR passage to leak coolant either internally or externally. If it leaks internally into the intake manifold and then the cylinders, it can result in "hydro-lock" of the engine. A simple coolant leak has resulted in a major problem that as best requires changing the spark plugs and oil in order to start the engine. That doesn't correct the cause of the problem though.

1. Remove the upper intake manifold.
2. Remove the EGR tube from the bottom plenum.
3. Install our new EGR port tube.
4. Use epoxy supplied with our repair kit to install our new adapter bushing in the upper plenum.
5. Reinstall the upper intake manifold.
(Detailed instructions are included with the kit)

As an added benefit, the smaller diameter of our EGR port tube creates an air space between the repaired (with adapter bushing) upper plenum and the new EGR port tube. This air space insulates the composite material of the plenum from further damage.
