STOP EXCESSIVE COOLANT CONSUMPTION OR LEAKAGE!!!!

20574
Engine Manifold
Repair Kit

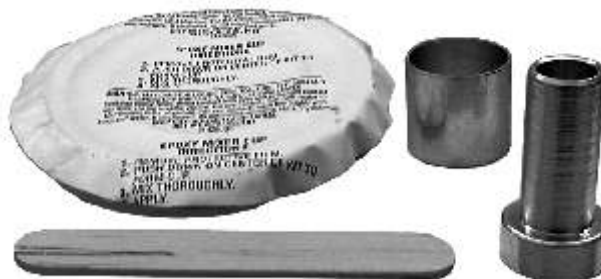
2003 - 1995 GM vehicles with 3.8 L series 2 engines (VIN K - RPO L36) have been experiencing excessive coolant consumption or coolant leakage near or under the throttle body and intake manifold. This is caused when the EGR tube on the lower manifold degrades the composite material of the upper intake plenum around the passage area between the two part manifold. Once the composite material is degraded, it becomes porous and allows the coolant areas on either side of the EGR passage to leak coolant either internally or externally. If it leaks internally into the intake manifold and then the cylinders, it can result in "hydro-lock" of the engine. A simple coolant leak has resulted in a major problem that as best requires changing the spark plugs and oil in order to start the engine. That doesn't correct the cause of the problem though.

Until now, the solution has been to replace the upper plenum and lower manifold at a retail cost of \$1200 - \$1400 for parts and labor. Yet that alone does not correct the root cause of the problem. Our 20574 repair kit offers an inexpensive but highly effective and permanent solution. Here are the steps involved:

1. Remove the upper intake manifold.
2. Remove the EGR tube from the bottom plenum.
3. Install our new EGR port tube.
4. Use epoxy supplied with our repair kit to install our new adapter bushing in the upper plenum.
5. Reinstall the upper intake manifold.
(Detailed instructions are included with the kit)
